# **Investigation of Failure in Main Fuel Pump of an Aeroengine**

M. Sujata, M. Madan, S.K. Bhaumik

Council of Scientific and Industrial Research (CSIR), National Aerospace Laboratories,  
Materials Science Division Bangalore 560 017

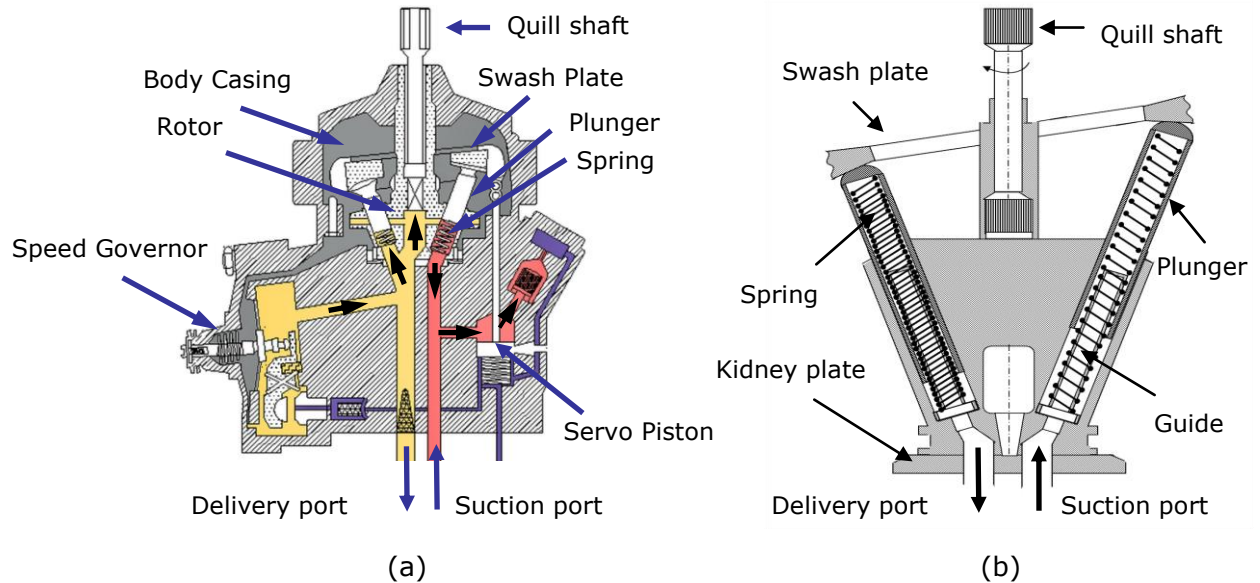
Schematic of the MFP is shown in Fig.1. The MFP in the present case is multi-plunger type and had nine plungers. The plungers are housed in the cavities or chambers of the rotor. For facilitating unobstructed up and down movement, each plunger is assembled in the rotor chamber with a guide and a spring. The plunger heads are crowned and in the assembly, they remain flushed with a swash plate. One end of the swash plate is fixed while the other end is operated by a servo piston. The angular position of the swash plate ensures up and down movement of the plungers when the rotor is on rotation. This facilitates the fuel to enter into the plungers and to deliver to the respective ports. At the bottom of the rotor, a plate having two kidney ports is fixed for the fuel to enter and to exit during each rotation of the rotor.

**Figure 1:** Schematic of (a) MFP in assembly, and (b) components of MFP

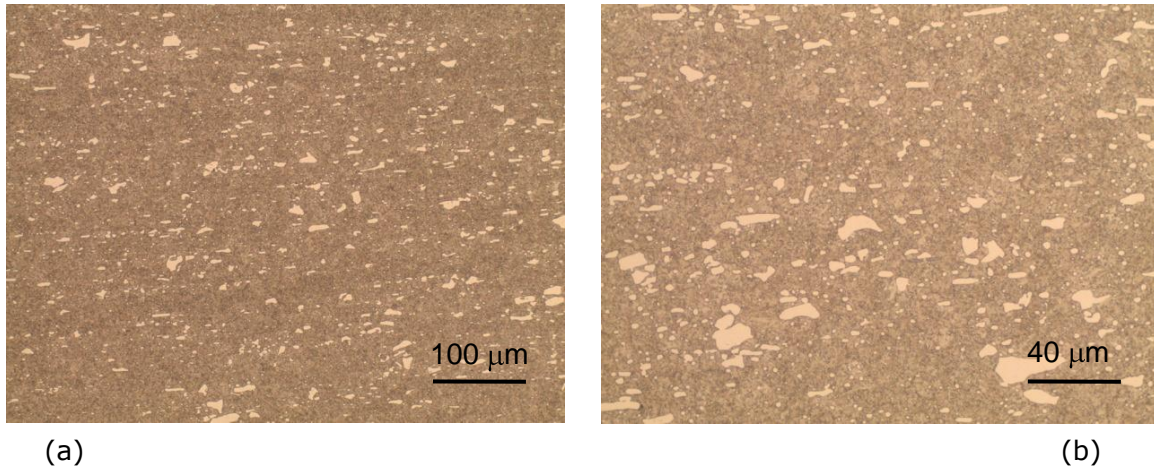
The material of construction of the plunger was evaluated and it conformed to the specification in respect of chemical composition (Table 1), microstructure (Fig.10) and hardness (62 HRC).

**Figure 10:** Optical microstructures of the plunger material showing satisfactory tempered martensitic structure dispersed with carbide particles: (a) longitudinal section, and (b) cross section (etched with 2% Nital solution)

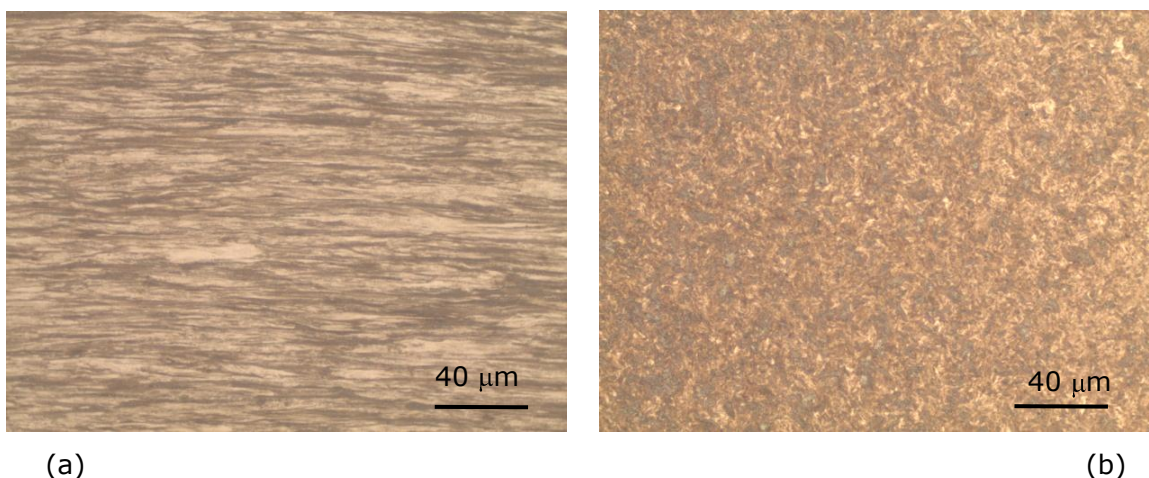
The material of construction of the springs conformed to the specification in terms of chemical composition (Table 3), microstructure (Fig.17), and hardness (50-52 HRC).

**Figure 17:** Optical microstructures of No.3 spring of the fuel pump showing satisfactory tempered martensitic structure: (a) longitudinal section, typical of cold drawn wire, and (b) cross section (etched with 2% Nital solution)
